Tech Tip 090016

HICAP and MIS series capture card issues with Dual Core CPUs or Hyperthreading

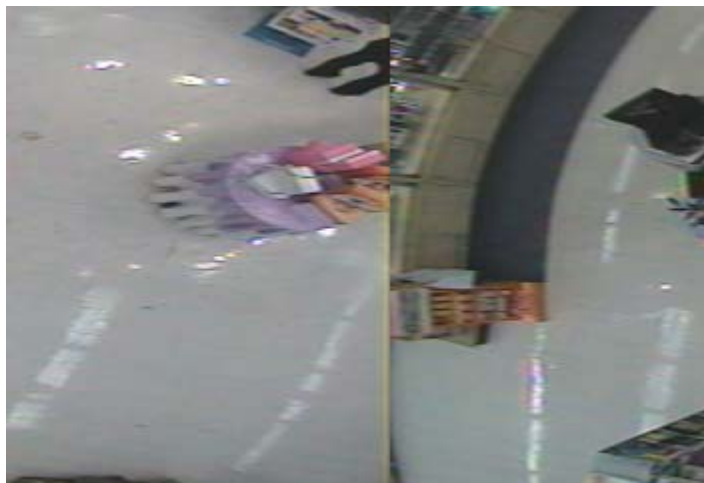
Image1: Distorted Image Example

Situation: When HICAP series cards with capture ability of 60 FPS or higher or MIS series capture cards are used in systems with Dual Core CPUs or with Hyperthreading enabled in the Motherboard BIOS, the video stalls frequently and can experience display issues.

Symptoms: The capture threads stall very frequently and images sometimes develop strange distortion, such as the image below.

HyperThreading: If you are using a motherboard with HyperThreading enabled, this feature can often be disabled in the Motherboard BIOS. Please refer to the Motherboard manual for details.

Dual Core CPU: If you are using a dual core CPU, to resolve this issue either switch to a single CPU system or switch to a different capture card.

Cards which are safe to use with HyperThreading or Dual Core CPU:

- Hicap50
- Hicap25
